HIGHLAND LAKE NORTH OUTLET

NH 00238

PHASE I INSPECTION REPORT
NATIONAL DAM INSPECTION PROGRAM

AUGUST 1978

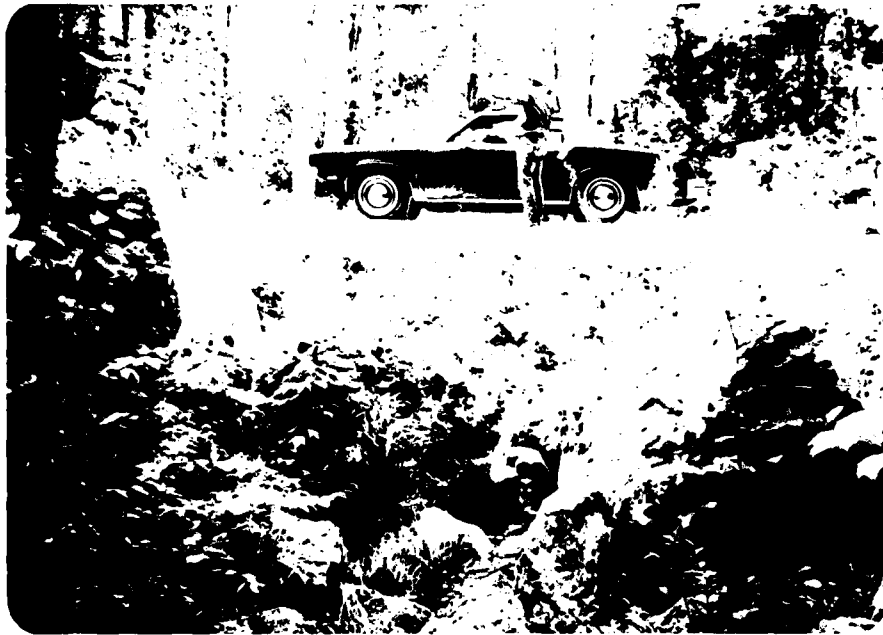
Overview photo of Tumlin Road crossing looking upstream

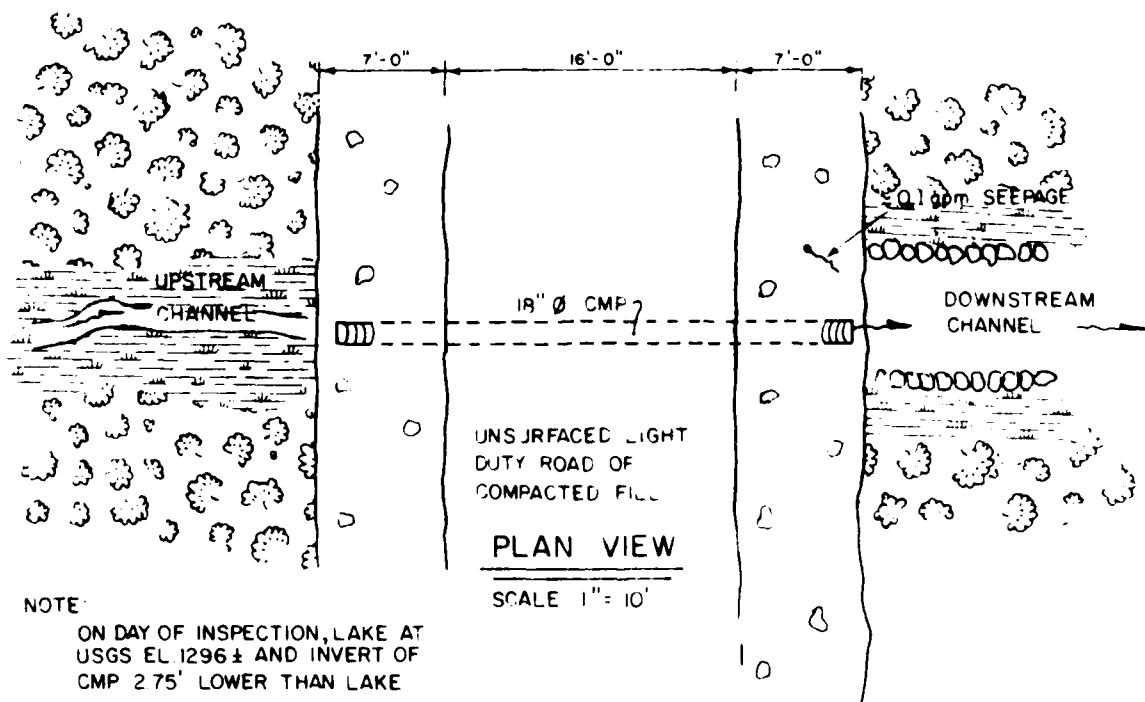
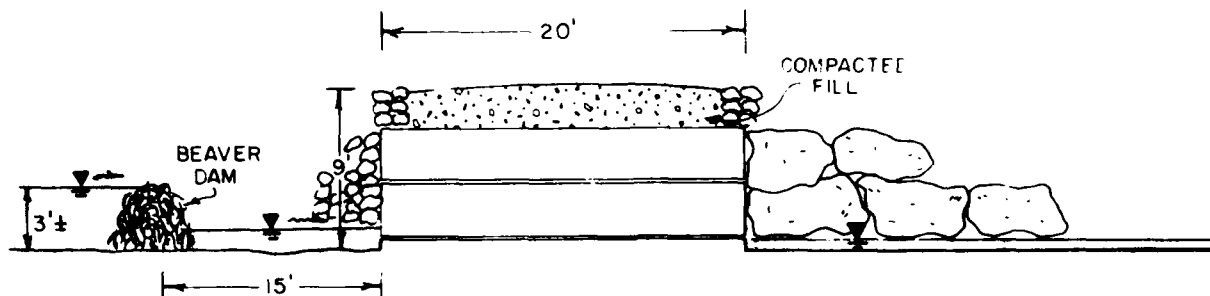
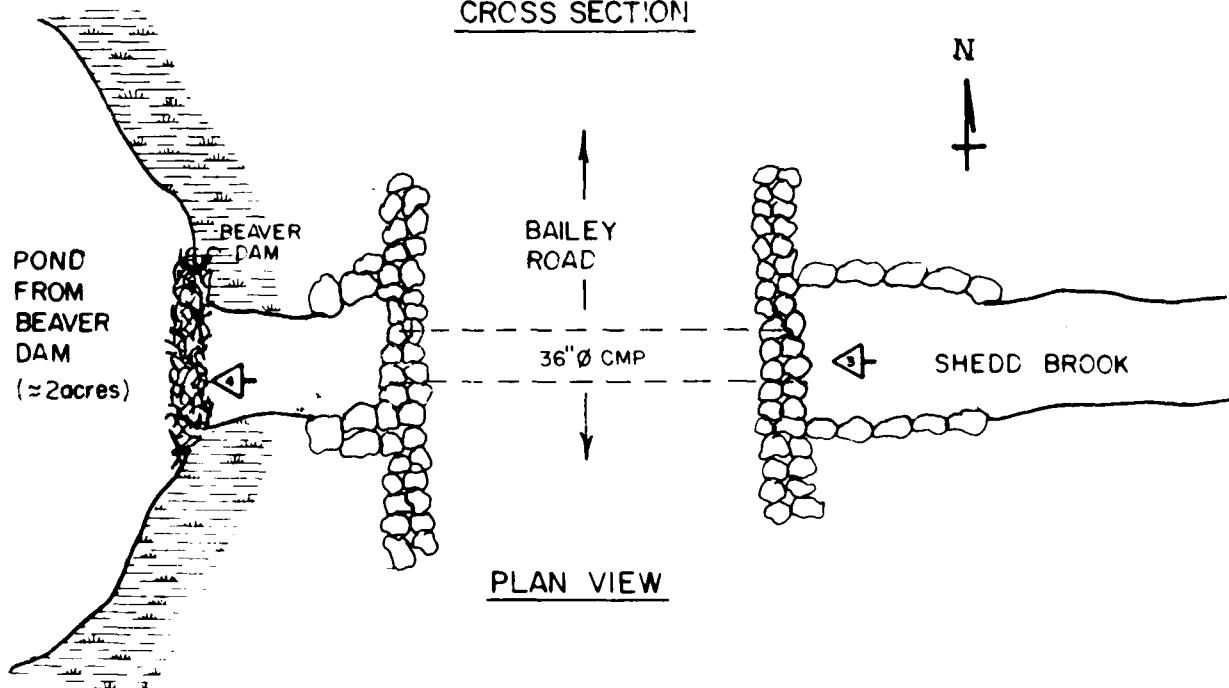
TUMLIN ROAD CROSSING

way. The top of the embankment is at USGS El. 1299.5+ or 3.5 feet above the normal pond (Figure 2). An 18 inch diameter corrugated metal culvert, with upstream invert at USGS El. 1293.3+, or 2.75 feet below normal lake level, carries Shedd Brook under the embankment, but the culvert inlet is completely blocked by beaver placed debris. If the lake rises above El. 1296+, the embankment would impound water to a maximum of 2500 acre-feet since the 18 inch culvert, even if cleared, could only pass a fraction of the flow in Shedd Brook under these conditions. Local residents refer to this structure as the North Outlet and it acts as a hydraulic control on the lake until overtopped.

NOTE: INLET OBSTRUCTED BY BEAVER DAM AND HEAVY SILTATION

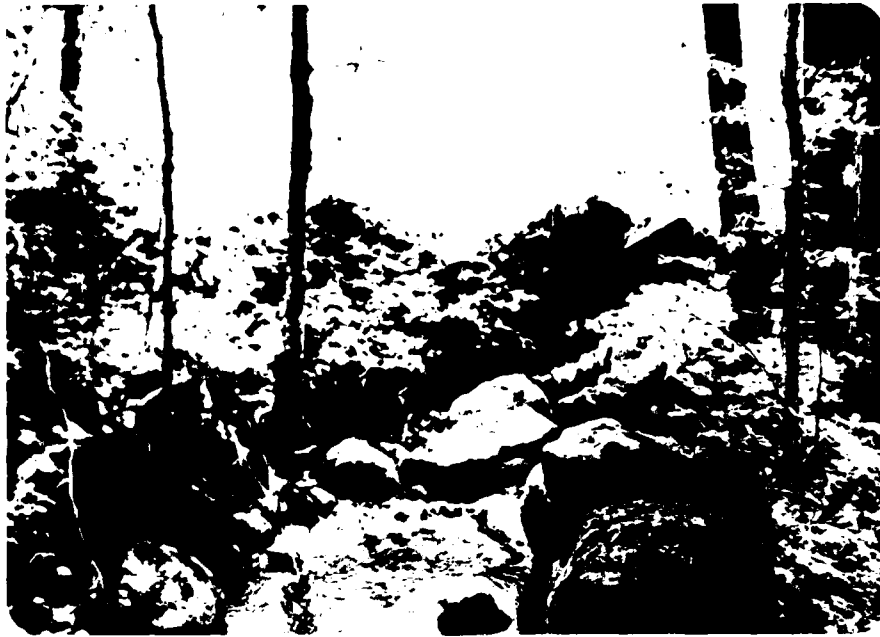
3. Outlet area for 2-36" CMP culverts under Bailey Road
